EQUIPMENT MANAGEMENT: SPIRAL OF PROGRESS

Alexander Chirkov

(Head of Materials, Corrosion, Diagnostics and Welding Department)
R&D Institute of Urea (NIIK)

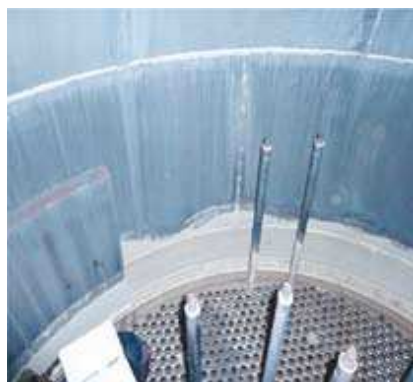
a) wave coming out of the hole

Picture 1.1 – Uneven melt level in the stripper

This observation during the inspection led to development of the ring-type liquid divider – a very low cost modernisation – that resulted in drastic efficiency improvement. Picture 1.2 a) shows uniform distribution of the melt

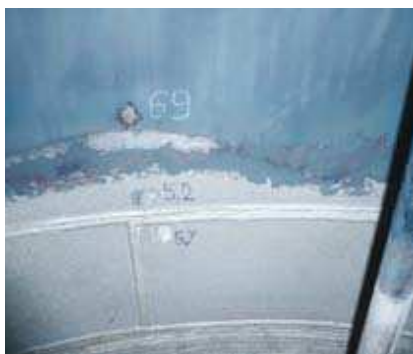
b) collision zone of two waves

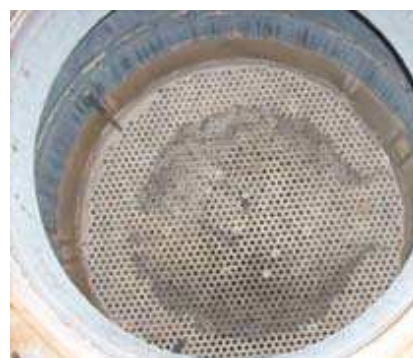
a) Ring liquid divider of NIIK design – deposits are located on the same distance from the wall

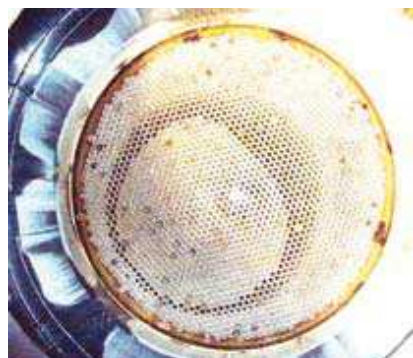
b) SBN ring liquid divider – evident dislocation of the deposits from the center of the tube sheet, deposits formation area varies greatly

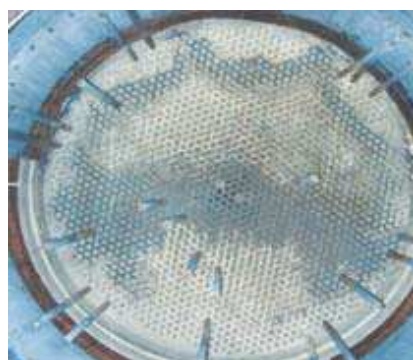
c) Tube sheet from a stripper with a half-ring liquid divider

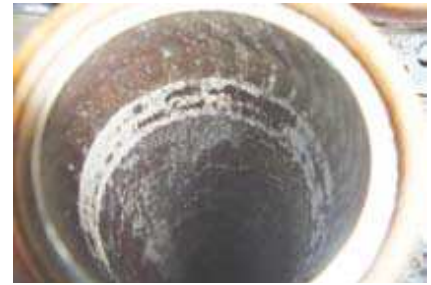
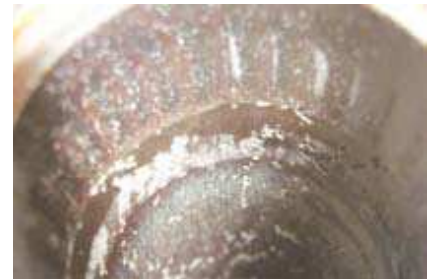
The inspection was carried out after the first year of operation. On the inner surface of heat exchanger tubes made of Sandvik 2RE69 serious pitting corrosion was noticed in the area of welding. The tubes condition is shown in Picture 4.1.

Picture 4.1 – Pitting corrosion on inner surface of heat exchanging tubes
The pitting was the result of the wrong welding parameters used at fabrication stage.

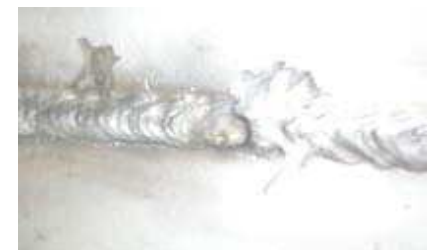
a) a pinhole on liner weld, the result of an arc impact after the electrode was removed

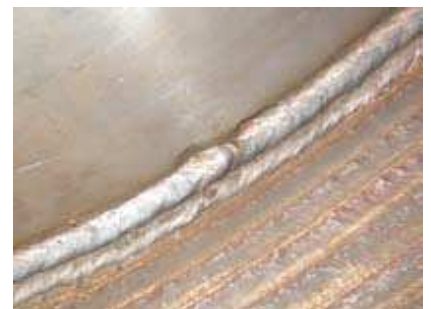
b) membrane weld joint lack of fusion during welding and cut up weld joint

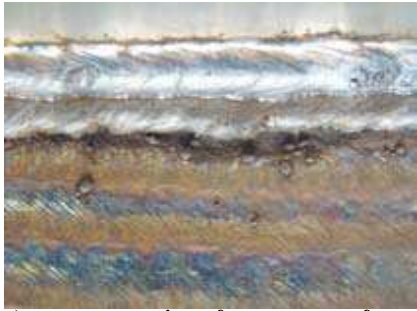
c) numerous spits – future areas of corrosion

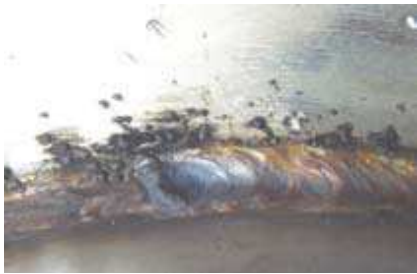
d) lack of shielding gas during welding – gray color of the joint

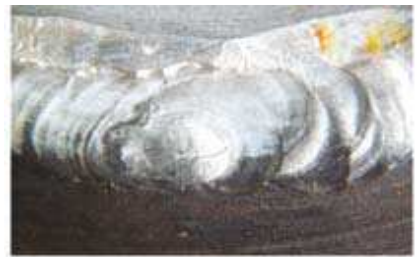
e) cracks nozzle welding joint

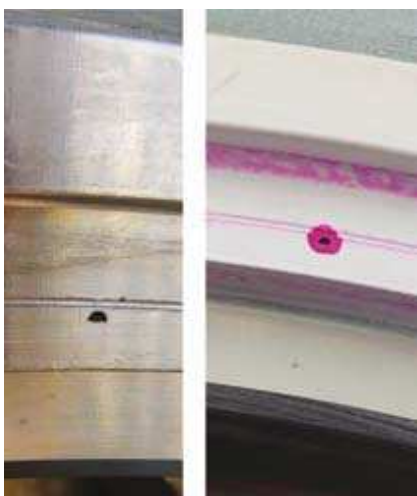
f) gasket surface cavities before and after dye penetrant test

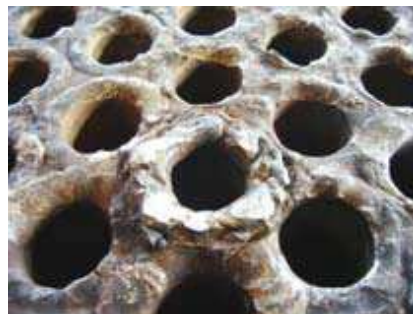
Picture 4.3 – Precondensator pos. E-303A tube sheet

Tubes material steel 316Ti did not match with the specified in engineering documents steel 316L UG. Tube to tube sheet welding joints did not correspond to design specifications. Some of the welds were performed using SMAW instead of TIG welding. Numerous cases of cavities and flux contamination were revealed. Two tubes were plugged during manufacturing. Tube sheet is shown in Picture 4.3.

a) actual welding joints

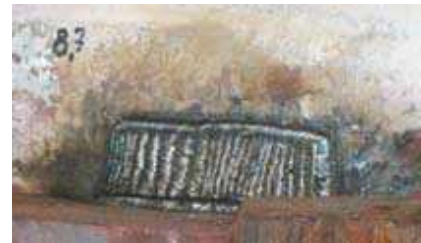
The vessel was a part of a relocated urea unit. The permission for operation of the vessel was issued by an organization that was authorized to grant permits, but lacked the most important aspect – expertise in urea plants inspections. After nine months of operation a leakage was observed in the shell of the vessel near the lower tube sheet. NIIK (R&D Institute of Urea) insisted that the operation of the plant must be stopped and the place of leakage thoroughly examined, but instead the plant management decided to weld a leaking area in the shell and continue plant operation. A week after there was another leakage in the shell and this time the plant was stopped to discover a major corrosion damage in the tube sheet. Repairs took more than 5 weeks.

a) welded shell penetration damage

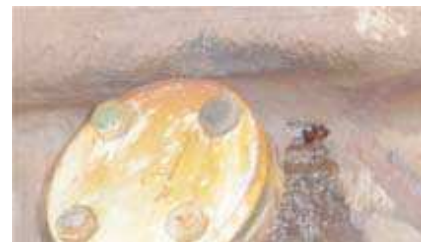
b) another shell penetration damage

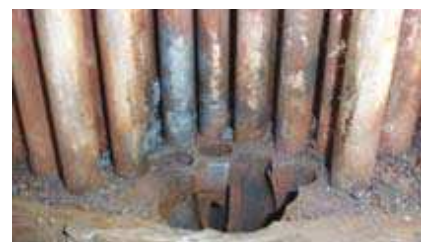
c) tube sheet damage revealed after shell and tubes were dismantled

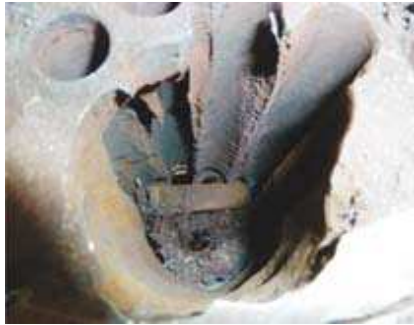
d) tube sheet damage

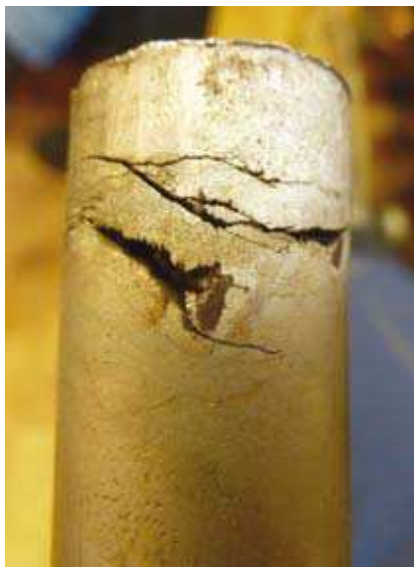
e) cracks in a tube from the tube sheet area

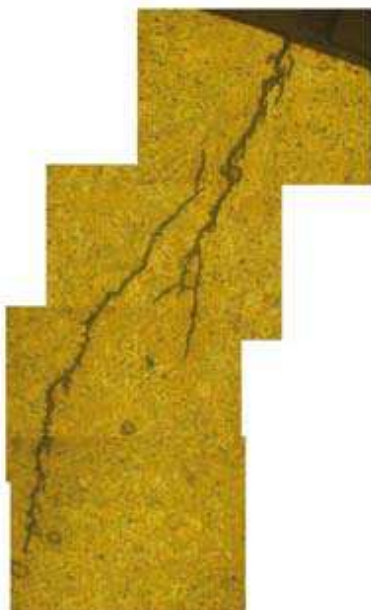
f) metallography examination of the tube

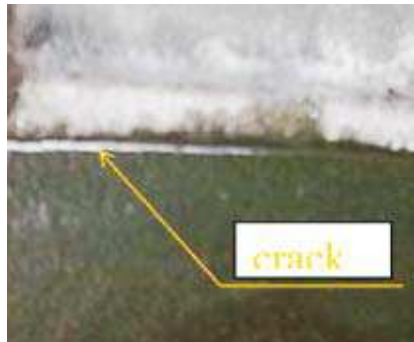
After the plant was shut down and reactor was opened internal inspection of liner welding joints showed a penetrating damage in a form of a crack in the welding joint between the second and the third liner belts (if counted from the top down).

a) crack in the ring weld joint between 2nd and 3d liner belt

Followed overhaul to evaluate the damaged shell area, shell repairs and liner replacement took 26 days of 24 hours' work. 26 days the plant has been shut down.

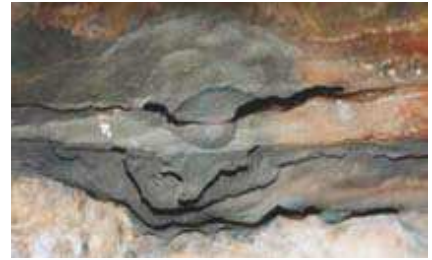
- 1) multiple layer shell of the reactor and the ring weld joint of the shell were damaged severely, corrosion depth was 25 mm (30% of the shell thickness);
- 2) the corrosion spread further under the liner.

b) Corrosion damage of the shell with the depth reaching 25 mm

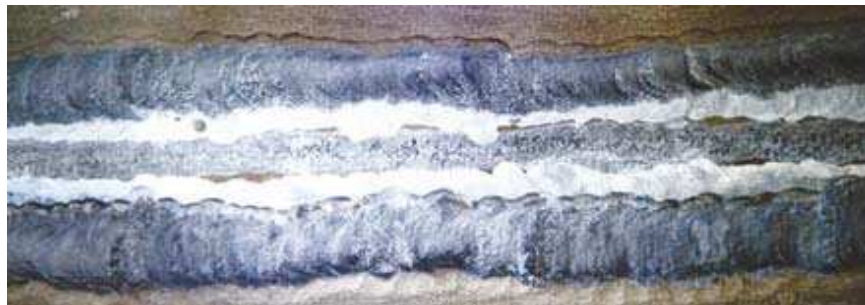
a) thinning in HAZ in repair welding joints with depth up to 1 mm – high amperage during the welding, black weld bead with cavities – insufficient protection of the welding groove

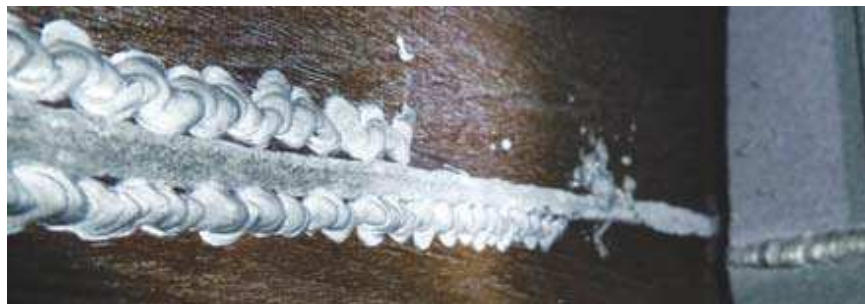
b) welding joint geometry deviations – welding at low amperage

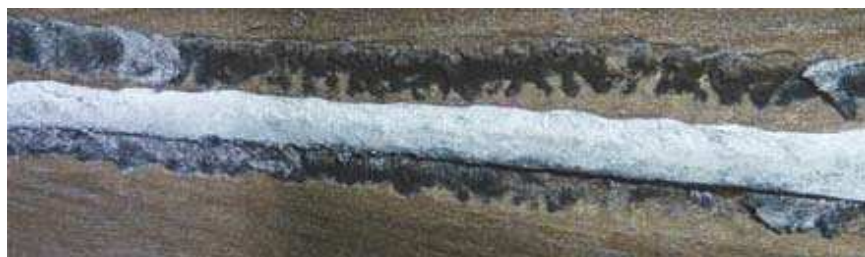
c) overlay welding joints completely destroyed by corrosion caused additional thinning of the liner with depth of 2 mm. Wrong welding consumables were used.

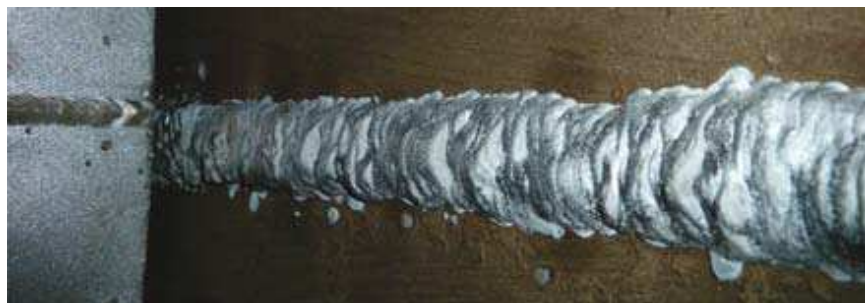
d) repair overlay of the base welding joint. Done manually by arc welding with a coated electrode – spits on base metal, bad weld joint geometry and large beads
