Repairing and Extending the Cycles of HP Vessels by SMAW in Urea Plant

Alexander Chirkov
and
Artem Panshin
NIIK Russia

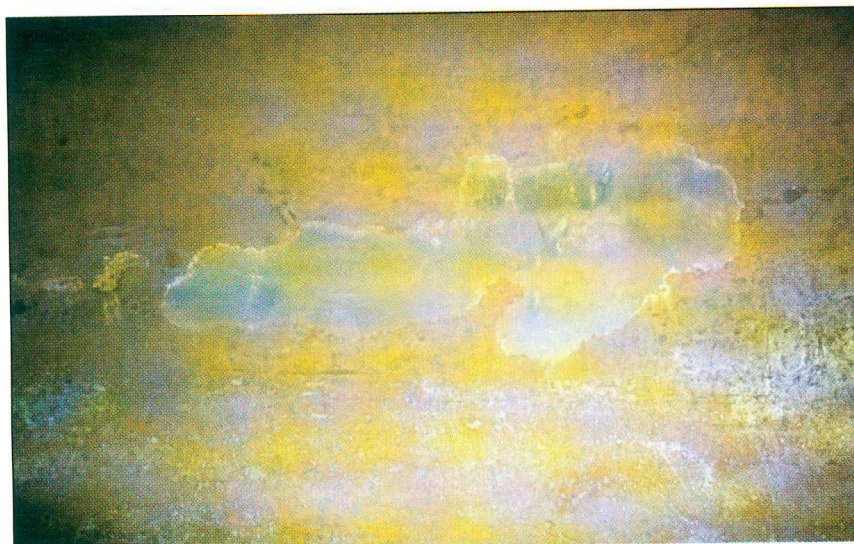
about 30 years. In 2009 a technical diagnosis of shell was carried out during a planned relining of the reactor, no damage were uncovered in the repair area (Figure 1).

Figure 1 – Repaired damage of urea reactor shell after 28 years of operation

Finally, an experimental repair method of carbon steel structural shell damaged by corrosion using SMAW welding with high austenitic electrodes was applied. Previously this method had been successfully used in power industry.

After repair, inspection of NIIK specialists didn't detect any deterioration of the reactor shell that had been in operation for

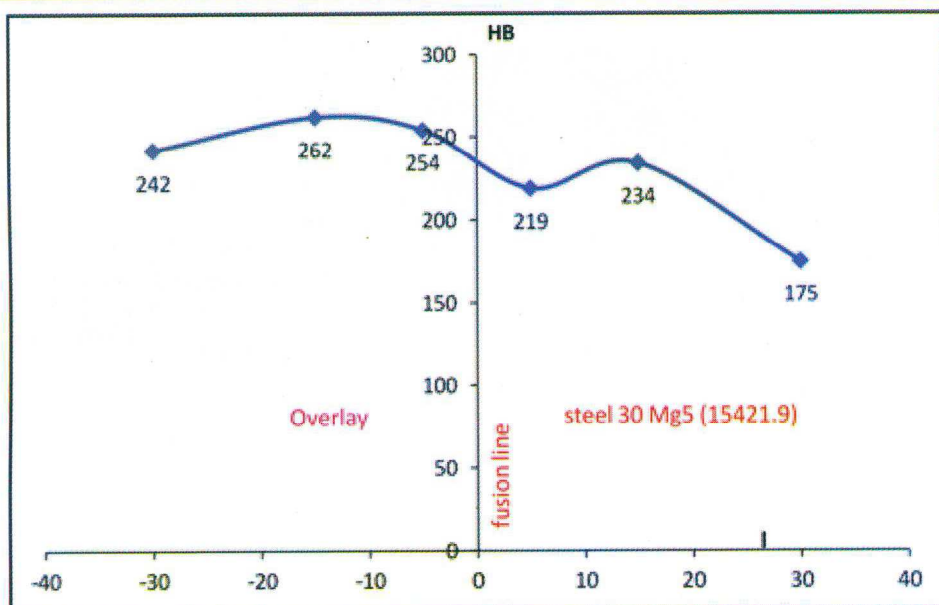
- ◆ Metallography and hardness tests of base metal, overlay metal and heat affected zones showed no critical hardness change and no hard brittle layers in contact zone (Figure 5).

Figure 5 – Fusion line and heat affected zone, scaling x500
Hardness measurement diagram

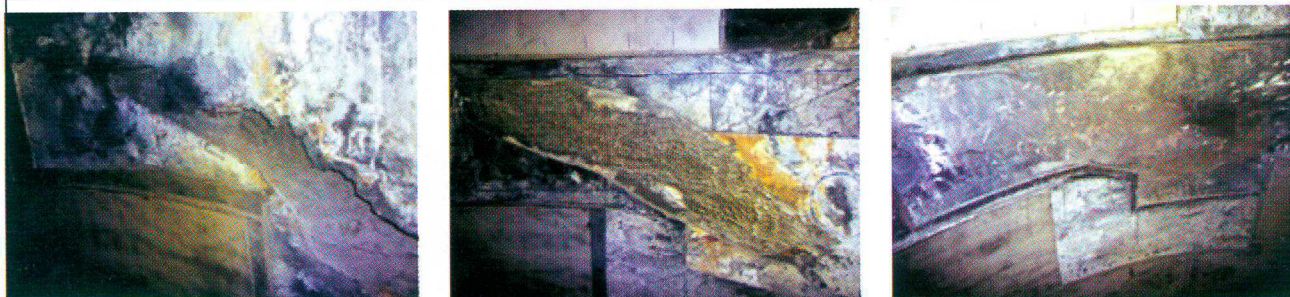
a) depth of single-layer reactor wall damage is up to 30mm (32%)

b) damage after welding

c) damage after grinding flat with shell surface

Figure 6 – Repair of Snamprogetti reactor shell, capacity 1500 MTPD

Recently, the method has been successfully used for a repair of 5 reactors with damage depth ranging from 20 mm to 50 mm.

Typical example of repaired damage is presented in Figure 6.
